Montana Department of Natural Resources and Conservation
State Water Projects Bureau

Project Information Report

December 2008

Future Priorities for Rehabilitation - Estimates of Costs for Water Users and DNRC

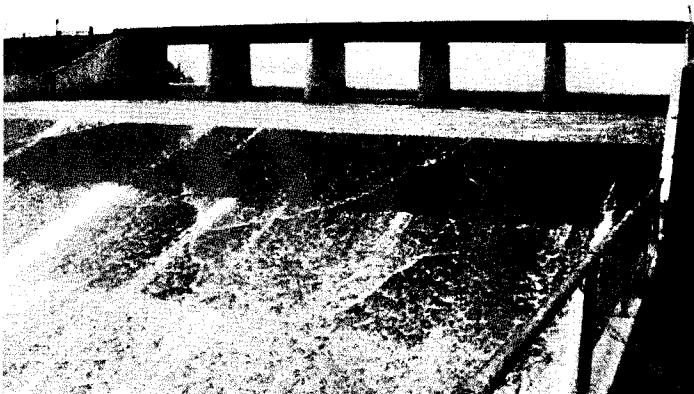
- ◆ Voids underneath the spillway and offset joints indicate progressive deterioration.
- ◆ Sedimentation has greatly diminished the storage capacity by about 50% (based on aerial photography the existing capacity is estimated at 3752 acre-feet).

Spillway and county road bridge

- ◆ Replace the spillway with a new structure.
- ◆ Restore lost storage capacity.
